# GLASTAR SERVICE BULLETIN 48

## Mandatory

**Subject:** Elevator Bellcrank Clearance Inspection and Aileron Inspection Provisions.

**Applicability:** All GlaStar kits

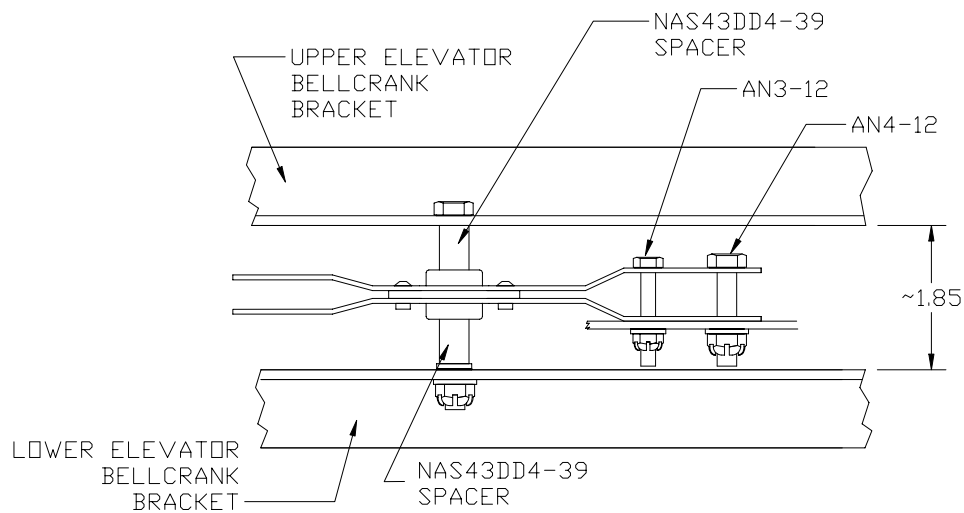
As the elevator bellcrank moves through its range of motion for controlling the elevator, adequate clearance should be maintained at all times between all moving parts to avoid potential interference and binding of the control system. When the builder first installs the upper and lower bellcrank brackets in the fuselage as prescribed in Figure 85 of Section VIII, the Assembly Manual does not give a controlling dimension, but rather just says to use the “clamped up assembly”. If the brackets are installed properly and parallel to each other, the distance between the upper and lower brackets should be approximately 1.85 inches as shown in Figure 1 below. Since the two NAS43DD4 spacers are of equal length, the bellcrank assembly is centered between the two brackets. But when the control cable, elevator stop and elevator pushrod hardware is installed, the clearance at the bottom of the two bolts shown in Figure 1 is marginal or inadequate.

Figure 1. Elevator Bellcrank Assembly and Installation per the Assembly Manual.

For those airplanes that are already flying or which have all the control rigging done and the tail section closed out, the primary importance is an inspection of the system as you have installed it. Remove the lower fuselage inspection cover and with a mirror and adequate lighting, move the elevator controls through its range of motion and measure the clearances between the upper and lower ends of the three bolts on the bellcrank. **The minimum recommended clearance on the lower edge of the bolt should be approximately 3/16 inch.** If you find your clearance is less than the minimum, you can gain 1/8 inch by switching the bolts over to an AN4-11 and an AN3-11 from the AN4-12 and AN3-12 as specified in the assembly manual. If you need additional clearance, then use the NAS43DD4 spacers specified in Figure 2. **Before you attempt to replace any hardware, the cable tension will have to be released on the elevator control cables.**

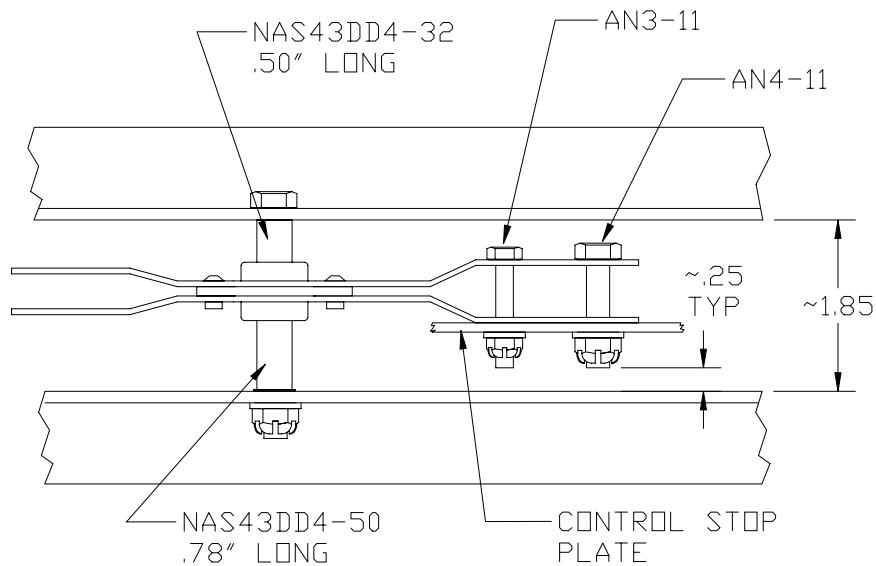
Figure 2. Modified Elevator Bellcrank Installation for Improved Clearances

Figure 2 below gives a more optimum arrangement when installing the bellcrank assembly between the upper and lower brackets. By using unequal NAS43DD4 spacer lengths, the bellcrank assembly can be shifted up providing more clearance to the bottom of the bolts. By going to AN3-11 and AN4-11 bolts, additional clearance can be gained and still have adequate grip length for the bolts through the bellcrank assembly and the control stop. The builder should aim for .25 inches of clearance between the bolts and the bellcrank brackets. We have observed that the elevator pushrod attach bolts on the bellcrank assembly tend to deflect marginally up under a positive or tail down load (approximately .05”). Therefore, slightly more clearance should be provided between the head of the bolt and the upper bracket.

The NAS43DD4 Bolt Spacers can be made from 6061-T6 or 2024-T4 aluminum with an outside diameter of .38 - .50 inch. The bare material should be primed for corrosion protection. A Service Bulletin Kit **P/N GSSB48KIT-1** is available through Newglasair, LLC for \$11.99. This kit includes two new NAS43DD4 bolt spacers and the AN3-11 and AN4-11 bolts.
