# GLASTAR SERVICE BULLETIN 5

**Subject:** AN470A4-7 soft rivets

**Applicability:** GlaStar tail and wing kits shipped prior to 10/1/95 with the following kit serial numbers: Tail kits #5002—5116, excluding 5004; Wing kits #5002, 5003, 5005—5008, 5011, 5012, 5014—5019, 5021, 5022, 5024, 5025—5032, 5034—5041, 5043—5045, 5048, 5049, 5051, 5052, 5054, 5055, 5059—5061, 5063, 5064, 5066, 5068, 5069, 5071, 5072, 5075—5077, 5080—5082, 5084, 5085, 5087—5090 and 5104

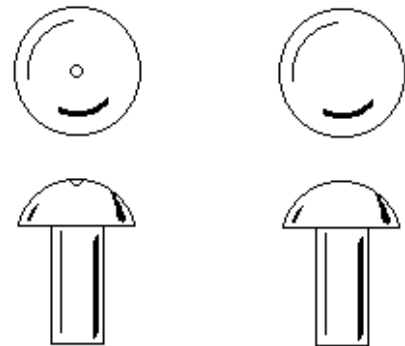
Figure 1

**Discussion:** It has come to our attention that the supply of AN470AD4-7 universal-head rivets shipped with several GlaStar tail and wing kits was contaminated with some AN470A4-7 rivets. These "A"-series rivets, which were inadvertently mixed in with the "AD"-series rivets by our vendor, are made of a much softer aluminum alloy than the "AD"-series specified for the GlaStar and therefore have insufficient strength. **They should not be used anywhere in GlaStar construction.**

**Required Action:** First, inspect your supply of AN470AD4-7 rivets and **remove** all the soft, "A"-series rivets. They can be distinguished from the "AD"-series rivets by the heads. As shown in Figure 1, the standard, "AD"-series rivets have a small dimple in the center of the head, while the soft, "A"-series rivets have plain heads.

**"AD"-series  
hard  
dimpled head**

**"A"-series  
soft  
plain head**

Second, inspect the GlaStar assemblies specified in Table 1 (if you have completed them) to see if any soft, "A"-series rivets were used. If you discover any soft rivets, you must **drill them out and replace them** with proper AN470AD4-7 rivets. If necessary, refer to "SECTION II: TOOLS AND TECHNIQUES" in the *GlaStar Assembly Manual* to refresh your memory on the proper procedure for replacing defective rivets.
