Service Bulletin 69 Rev A

Subject: Seat Belt Anchor Points for Sportsman and Glastar Aircraft and Shoulder Harness Anchor Points for Glastar Aircraft

Applicability: All Glastar and Sportsman Aircraft

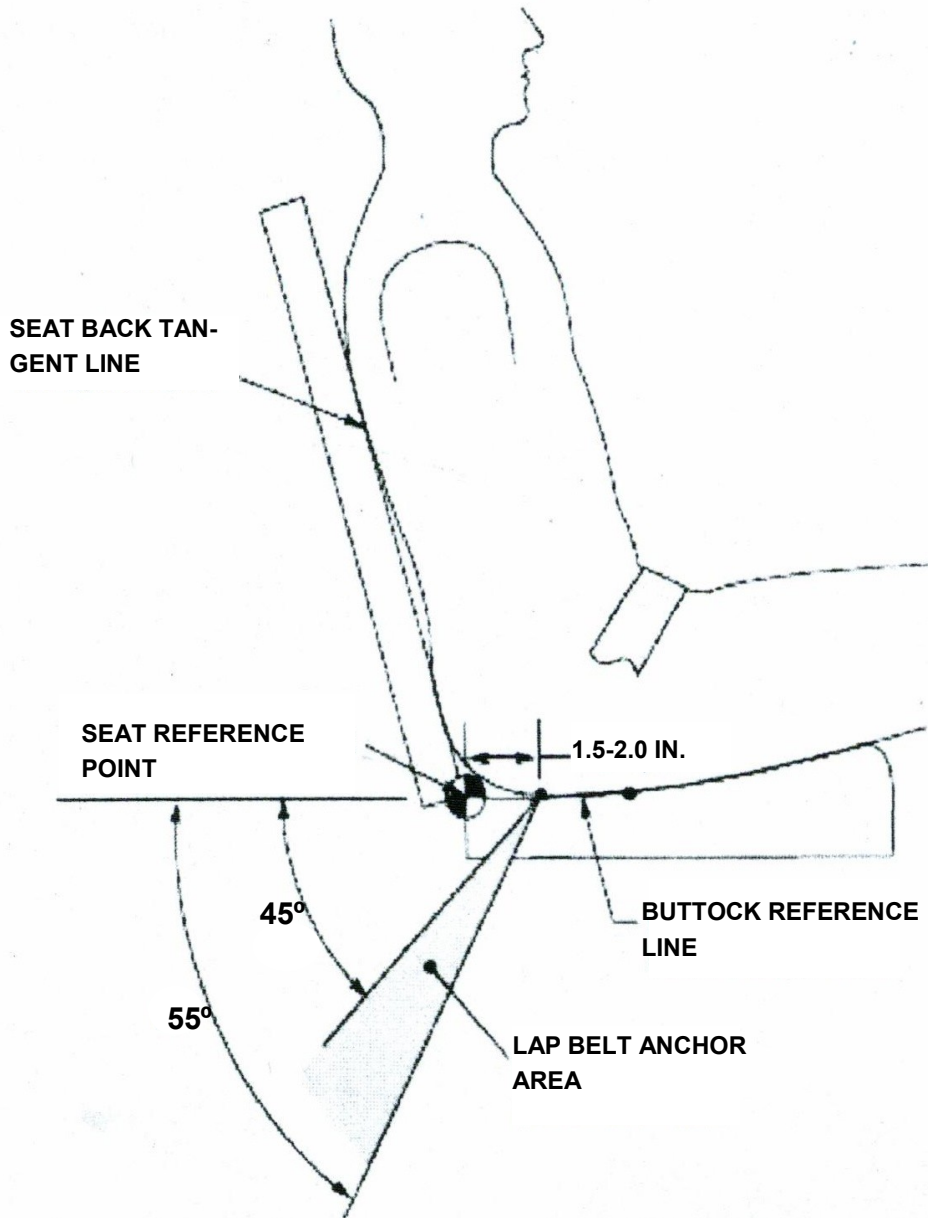
FAA Advisory Circular AC21-34 Shoulder Harness - Seat Belt Installations provides information and guidance for installation of shoulder harness and safety belt restraint systems. AC21-34 recommends that lap belt anchor points mount so as to maintain an angular range of 45° - 55° for all seat range positions. (See Figure 1 on page 2.) In addition, AC21-34 recommends that shoulder harness anchor points mount so as to maintain an angular range of -5° to +30° for all seat range positions. (See Figure 2 on the page 3.)

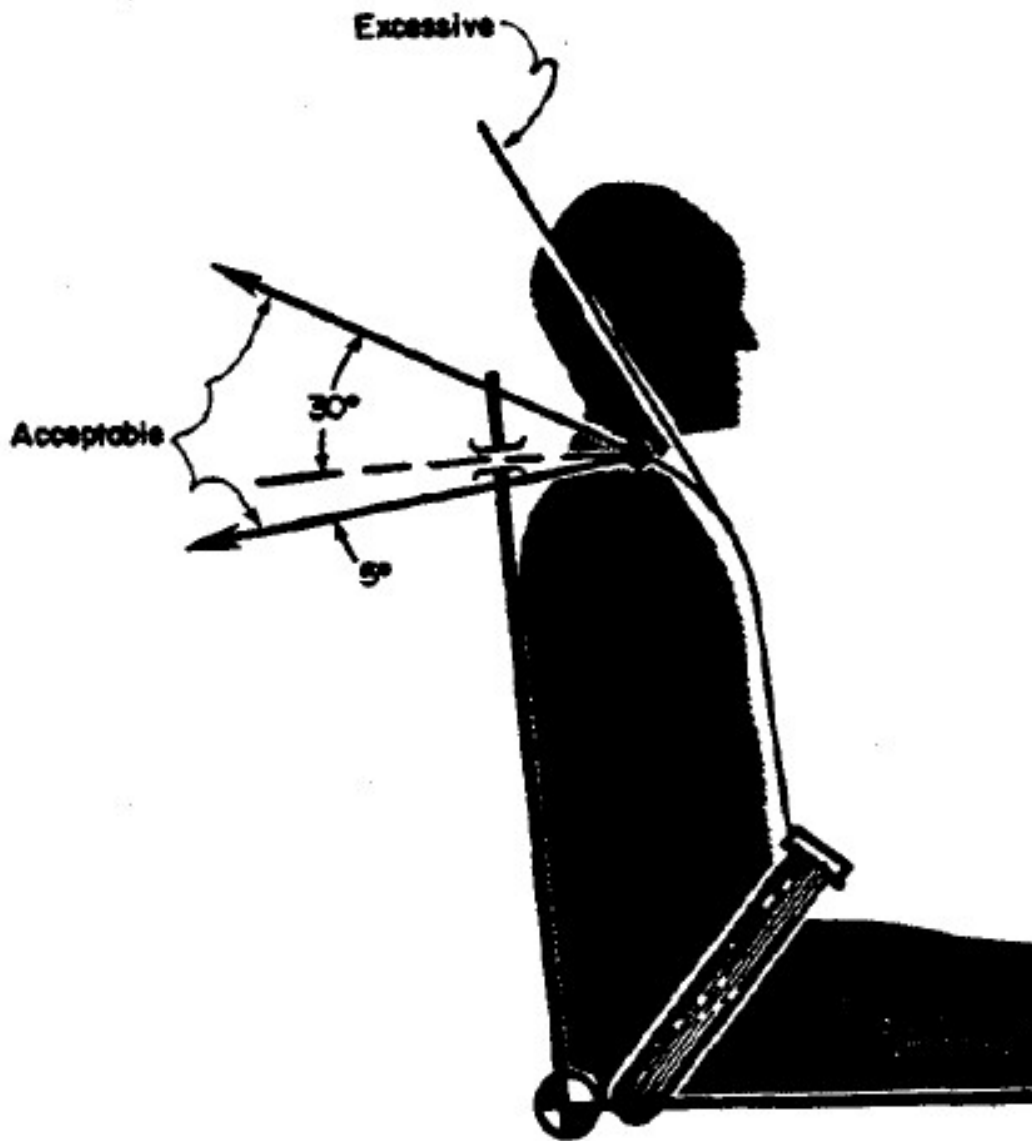
Figure 2

Since issuing SB69, it was discovered that Glastar shoulder harness upper attach points are not within the suggested angles of -5° to +30° of shoulder height. Thus, a shoulder harness cross bar retrofit kit (p/n 930-07300-201) was created to move these attach points to within the suggested range.

The cross bar retrofit kit lowers the attach points for shoulder harness anchor points in Glastar aircraft. Detailed step-by-step instructions are provided with the Retrofit Kit along with all necessary parts and hardware. A copy of the Retrofit instructions can be viewed on our website at <http://www.glasairaviation.com/advisglastar.html>

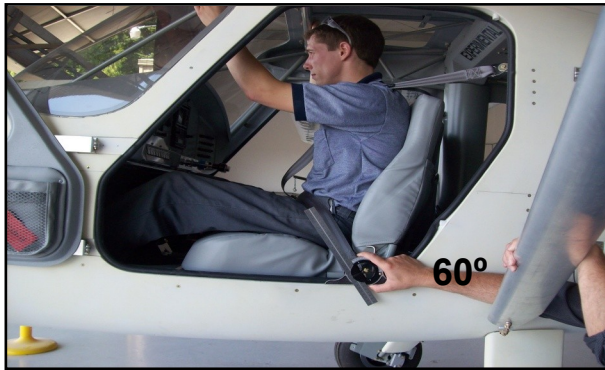
As currently configured, the Glastar / Sportsman lap belt anchors can fall outside of the recommended angular range, especially when the seat backs are in the mid to aft locations. (See photos in appendix.)

Current configuration:
Seat-back in forward position

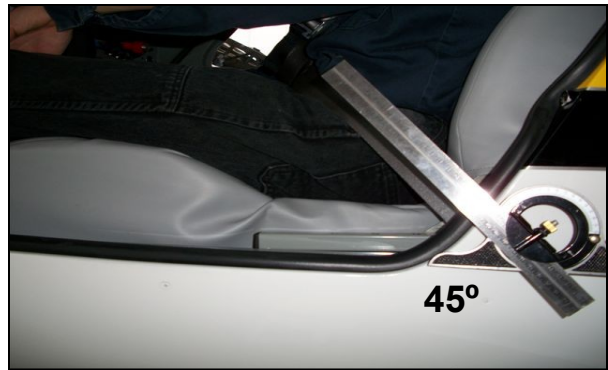
Retrofit (New) configuration:
Seat-back in forward position

For existing Glastar / Sportsman aircraft, Glasair Aviation has developed two Retrofit Options to re-locate the lap belt anchor points to new production specifications.

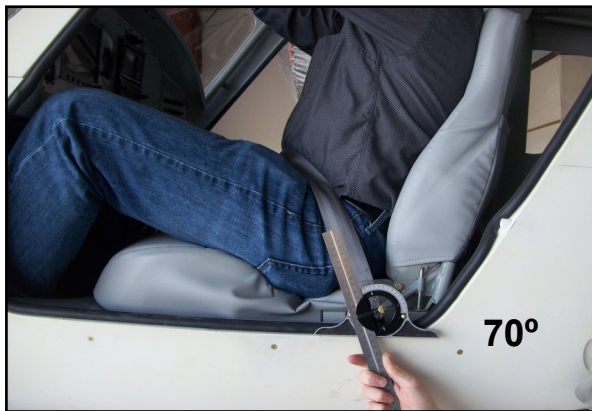
Current configuration:
Seat-back in mid-position

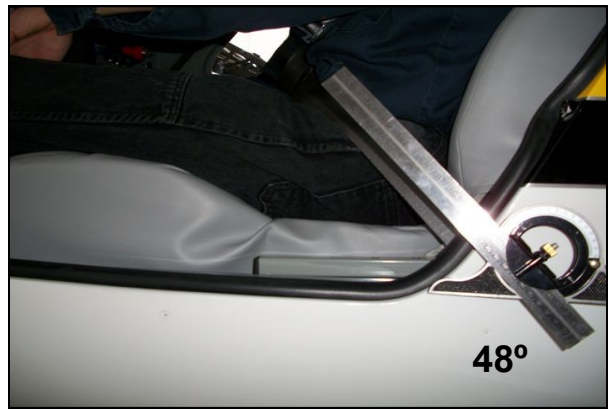
Retrofit (New) configuration:
Seat-back in mid-position

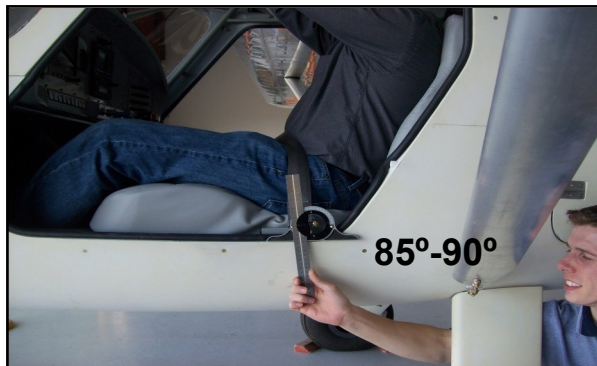
Current configuration:
Seat-back in aft position

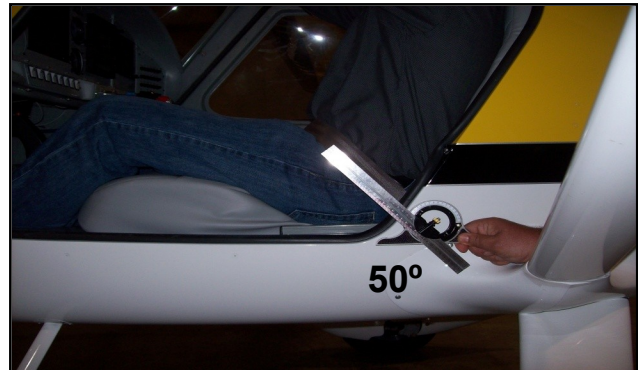
Retrofit (new) configuration:
Seat-back in aft position
