Service Bulletin 70

Vertical fin cracks

All Sportsman aircraft

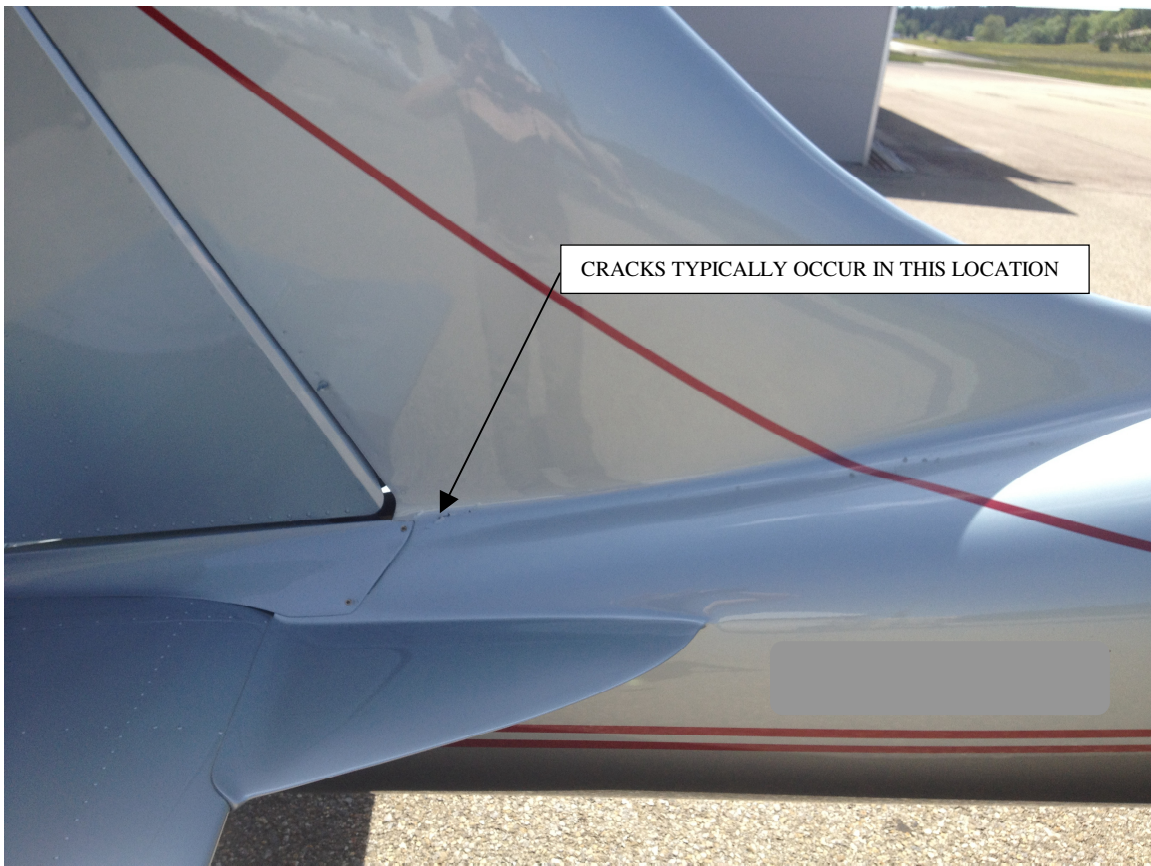
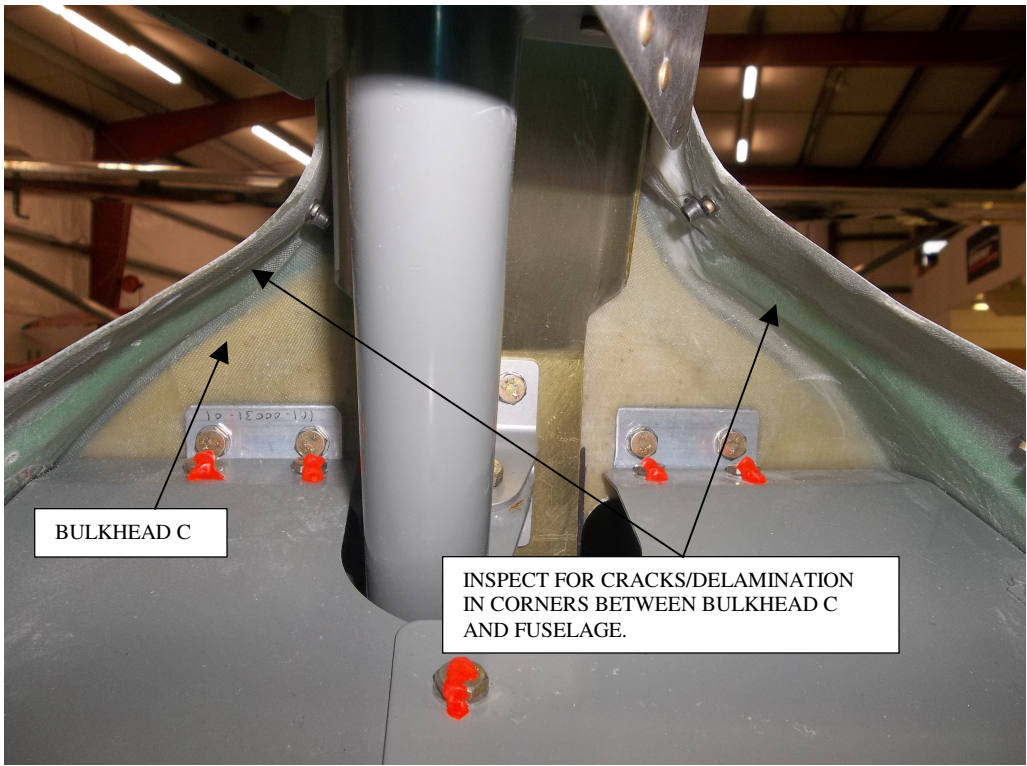
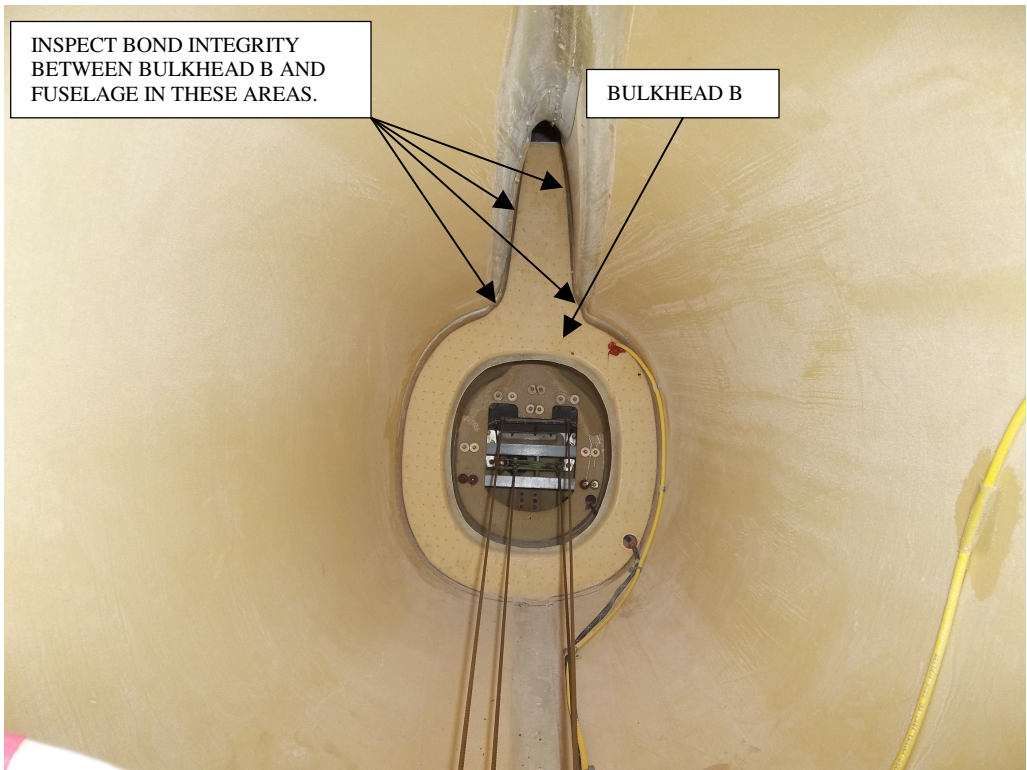
INSPECTION:

A few owners of Sportsman aircraft have reported cracks showing up at the aft base of the vertical fin and in some instances have reported cracking of the laminates and adhesion bond between bulkheads B and C and the vertical fin. Exterior cracking is most commonly found on the right-hand side where the vertical fin meets the aft fuselage at its base. The left-hand vertical fin is molded as a part of the fuselage, whereas the right-hand vertical fin half is bonded to the fuselage and vertical fin as a separate piece during fuselage assembly. The exterior cracks are commonly showing up along the bonding joint. Minor cracking may simply indicate separation of the cosmetic filler used in paint preparation.

Some movement of the vertical fin occurs when the rudder is actuated in flight. The degree of movement is dependent upon the speed of the plane and the force exerted on the rudder controls. A lack of evidence of cracking on the exterior does not necessarily mean that disbonding between the bulkheads and the vertical fin on the inside is not occurring. A simple test of the integrity of the vertical fin is to take hold of it near the top and firmly pull it side-to-side, watching the movement and listening for any sound of separation inside. Ultimately, a visual inspection of the bulkheads will determine the action required.

Bulkhead B can be inspected by crawling into the aft fuselage. Bulkhead C can also be inspected from the inside, but is best inspected by removal of the rudder base fairing. If cracking or separation is evident in the bonding laminates between the upper portion of bulkhead C and the vertical fin, then deeper inspection will be necessary through the lower inspection hole or removal of the stabilizer.
