Service Bulletin 69 Rev A

Subject: Seat Belt Anchor Points for Sportsman and Glastar Aircraft and Shoulder Harness Anchor Points for Glastar Aircraft

Applicability: All Glastar and Sportsman Aircraft

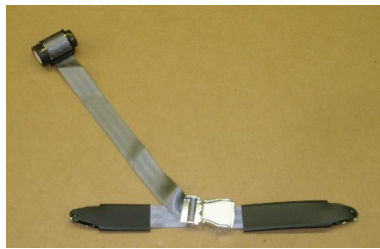
Inertia Reel (three point) Seat Belt Installation Kit: p/n 930-7200-301 (includes 2 seatbelt/inertia reels) \$595.00*

(Both Sportsman and Glastar aircraft can be equipped with inertial reel seat belts if the optional steps of welding the brackets in place are completed per the Anchor Point Retrofit Kit. Inertia reel belts do not have Sportsman / Glastar patches sewn on.)
